STRUCTURAL BEHAVIOR OF WIND FRAME TRUSSES IN BRIDGES AFTER CRASHES USING LISA V8 FEA

Abstract. A trailer towing large machinery struck the Pondok Gong truss bridge in Samboja, East Kalimantan, at 80 km/h, seriously damaging the 60-meter steel structure. By utilizing Finite Element Analysis (FEA) with LISA v.8, the research seeks to close the knowledge gap about the post-collision behavior of the bridge elements. With an emphasis on the wind bar frame and bracing that underwent ripping and distortion, the study simulates the impact to assess stress distribution and deformation patterns in the impacted structural components. The impact stress on the wind bracing elements was found to be 567,066 kN/m² in the simulation, which is far more than the permitted stress of 246,670 kN/m² for the steel. This discovery calls attention to significant structural flaws and demands quick response. It is advised to reinforce the impacted areas to stop further failures and replace the damaged sections with new steel components made to tolerate higher loads. Maintaining the structural integrity and safety of the bridge during the replacement process requires constant observation and monitoring.

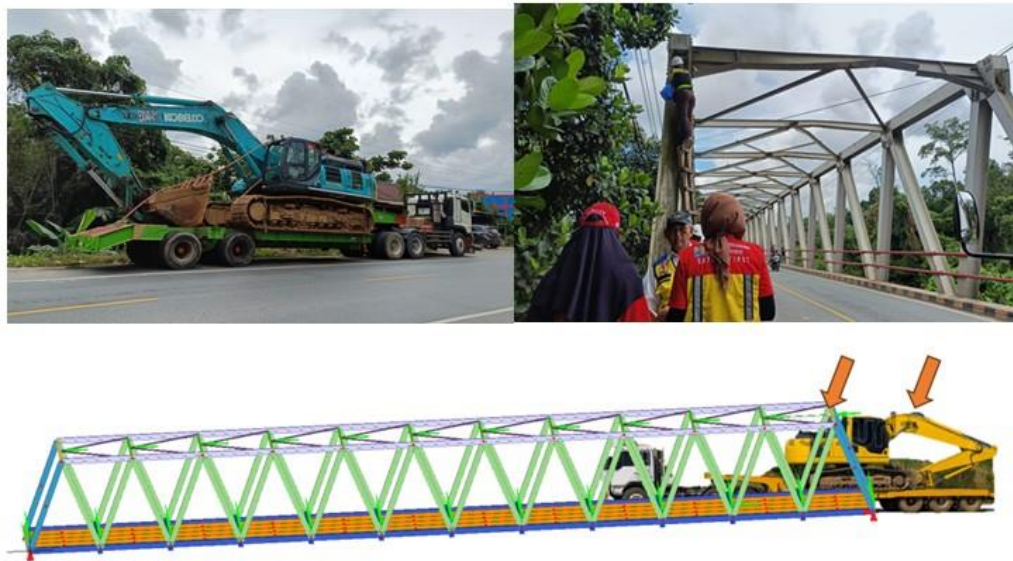
Figure 1. Crash simulation.

Bridge structures are critical elements in transportation networks, often subjected to various types of loading, including vehicular impacts. Such incidents can significantly affect a bridge's structural integrity, necessitating thorough investigation and analysis. This paper investigates the Pondok Gong bridge, a 60-meter steel truss bridge of Australian design, which was struck by a trailer carrying heavy machinery. The impact resulted in significant damage to the bridge's wind bracing system, posing potential risks to its stability. The identified research gap of this investigation resides in the lack of a comprehensive simulation study using Finite Element Analysis (FEA) to assess the post-collision behavior of bridge elements in an actual collision scenario, as depicted by a heavy truck carrying an excavator. Although initial on-site inspections showed significant damage to the wind braces and diagonal members of Pondok Gong Bridge, there was a need to model and analyze the stress distribution and deformation patterns in the affected structural components. This gap highlighted the absence of detailed post-impact stress and behavior analysis, which could be effectively simulated using LISA V.8 FEA to better understand how the bridge structure responded under such dynamic loading conditions. By simulating the collision between the trailer and the bridge's upper structure, the study aims to accurately predict the critical stress zones and evaluate the residual strength of the impacted elements. The investigation will provide insights into the structural integrity of the damaged bridge and inform necessary repair or reinforcement strategies, ensuring the continued safety of the bridge for public use, shown in *Figure 1*.

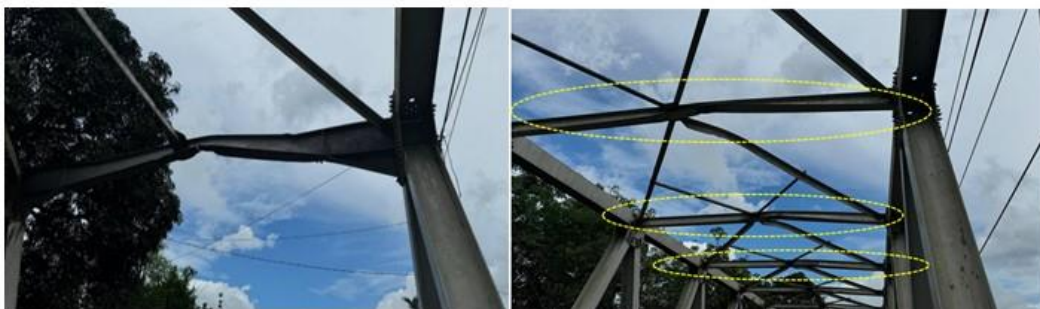
Figure 2. Damaged elements after a crash.

The Pondok Gong truss bridge wind bar frame located in Samboja, East Kalimantan was hit by a heavy vehicle transporting heavy equipment where the heavy equipment arm hit the horizontal wind bar frame of the truss bridge directly, the vehicle travelled at a speed of 80 km/h, hitting the entire horizontal wind bar frame and bracing on the Pondok Gong truss bridge. The heavy equipment transported by the trailer exceeded the allowable height, so the impact caused severe deformation of some wind tie bracing and tearing of the structural elements of the horizontal wind bar frame on the Pondok Gong truss bridge. investigation focuses on understanding the impact force, structural damage, and the extent of deformation, shown in *Figure 2*.

The Pondok Gong truss bridge in Samboja, East Kalimantan, experienced significant damage when a heavy vehicle, with an arm exceeding the allowable height, collided with the horizontal wind bar frame at a speed of 80 km/h. This impact caused severe deformation and tearing of the wind bracing elements, resulting in an impact stress of 567,066 kN/m². This value significantly exceeds the allowable stress of 246,670 kN/m² for the steel components. The Finite Element Analysis (FEA) using LISA v.8 accounted for various loading conditions, including a self-weight of 7.41 kN/m for the slab, an additional dead load of 1.65 kN/m, a traffic load of 6.75 kPa, and a truck load of 146.25 kN, which highlighted that the impact force greatly surpassed the material's yield stress. It is advised to replace the broken wind bracing elements with new steel parts made to withstand impact loads in order to solve this problem and stop structural collapse. To be more precise, parts that tore should be replaced with new steel that can bear stresses higher than 567,066 kN/m². Furthermore, strengthening these areas will guarantee that they can withstand additional loads or impacts without failing. In order to assure the long-term performance and structural stability of the bridge, as well as to confirm the integrity of the new components, constant inspection and monitoring are essential during the replacement process.

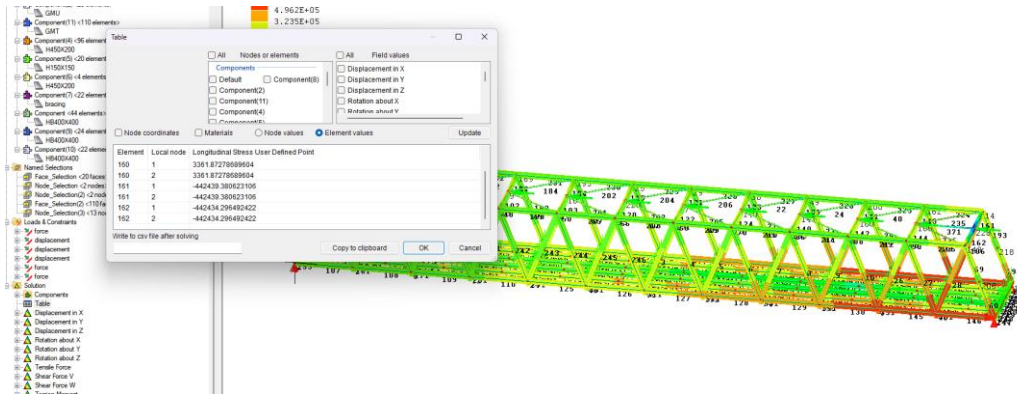
Figure 6. Stresses that occur.

Where; m is the mass, v is the velocity, and Δt is the contact time. For collisions that happen very quickly, as is common with hard objects like steel, the contact time can be very short. For example, if the contact time is 0.01 seconds (10 milliseconds), the impact force is approximately 66,660 kN. The FEM analysis revealed that the impact generated stress far exceeding the steel's yield stress, particularly in the wind bracing system. Key findings from the analysis include that the impact-induced stress was 442,434 kN/m², which is significantly higher than the allowable stress of 246,670 kN/m² for steel, shown in *Figure 6*. Additionally, post-collision field measurements revealed that the actual stress in the damaged wind bracing sections reached 567,066 kN/m², indicating a critical failure in these areas. This substantial exceedance of both the allowable stress and the actual measured stress underscores the severity of the damage and the need for immediate structural remediation. Researchers compare the impact stress with the previously computed permitted stress in order to ascertain whether the stress resulting from the impact of the heavy machinery 442,434 kN/m² exceeds the allowable stress for steel. Under the assumption that the permitted stress for steel is 246,670 kN/m² when a safety factor of 1.5 is applied, the comparison demonstrates that the impact stress is far higher than the allowable limit. In particular, 442,434 kN/m² is significantly more than 246,670 kN/m², suggesting that forces are applied to the material that are higher than what is safe.

The force applied to the structure from the collision of the heavy machinery is greater than the safe capacity of the material, as evidenced by the impact stress of 567,066 kN/m², which is higher than the permissible stress for steel of 246,670 kN/m². This implies that there is a considerable risk of structural failure or damage since the stress placed on the steel structure is higher than its intended tolerance. In these situations, the integrity of the building can be jeopardized, necessitating a rapid assessment and either reinforcing or replacing the damaged components to guarantee long-term performance and safety shown in *Figure 7*. The research showed that multiple parts had exceeded their yield limits, compromising the bridge's structural integrity as a result of the incident. If structural failure is not addressed, there is a high possibility of failure due to this degree of stress. As a result of the wind bracing's tearing and irreversible distortion upon contact, stress concentrations spread to nearby structural components. According to analysis, these damaged sections could buckle under extra stresses from the environment or from traffic. It is advised to replace the damaged wind bracing elements with new steel parts made to bear impact loads in order to solve these problems and stop structural collapse. Furthermore, reinforcing the impacted sections

will aid in preventing similar failures from being brought on by future impacts or load increases. In order to ensure the overall safety of the bridge and confirm the integrity of the new components, constant inspection and monitoring are necessary during the replacement process. Restoring the damaged or torn elements is the suggested course of action to address the stress from impacts that exceed steel's allowed stress capacity. New steel components with the mechanical capacity to sustain the associated loads and stresses should be used in place of these components. By replacing the structure, possible structural failures will be avoided by ensuring that it satisfies safety and performance criteria. Conducting comprehensive inspections and applying extra reinforcements if needed are essential to preserve the overall structural integrity and reduce dangers in the future during the replacement (*Figure 8*).
